Report/ *Relatório*

Rotational Stage in Operations and Maintenance Units of an Elevator and Automatic Escalators Enterprise in Brazil

Fredriksson, José
Master Mechanical Engineering

8th December 2020 – 5th March 2021

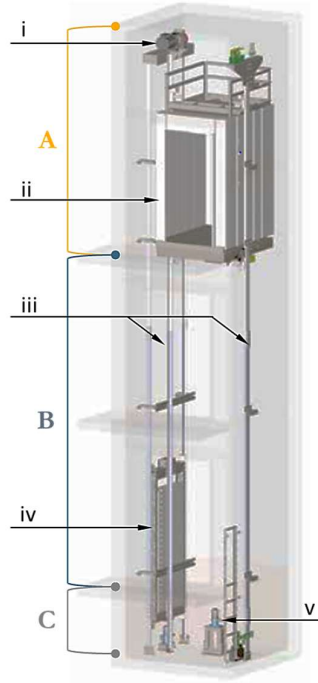
- A. Last height
- B. Shaft
- C. Pit

- i. *Lift machinery space*
Modern lifts are equipped with compact gearless and oil-free traction machines. This reduces noise and energy consumption.
- ii. *Cabine*
It is formed by different panels and its interior offers wide combinations of textures and materials
- iii. *Guiding rails*
The guides are fixed on the lift pathway for the cabin and the counterweight.
- iv. *Counter weight*
The counterweight has the function of helping the lift cabin to ascend and descend without the need for traction force from the machine
- v. *Shock absorber*
Impact buffering system according to international standards that minimizes damage in case the cabin exceeds its route limit

Figure 2 Elevator Elements at the example of a Compaq Slim machine room less [2]

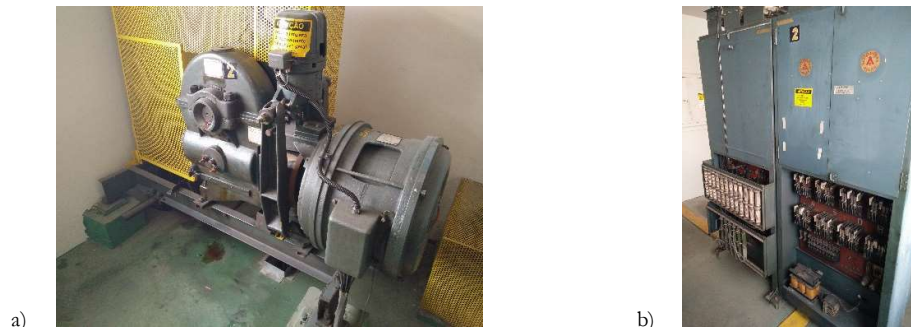
Figure 4 a) Motor with pinion shaft for 15 floor-building b) control cabinet with relais contacts from the year (1987) (photo, 12.2020)

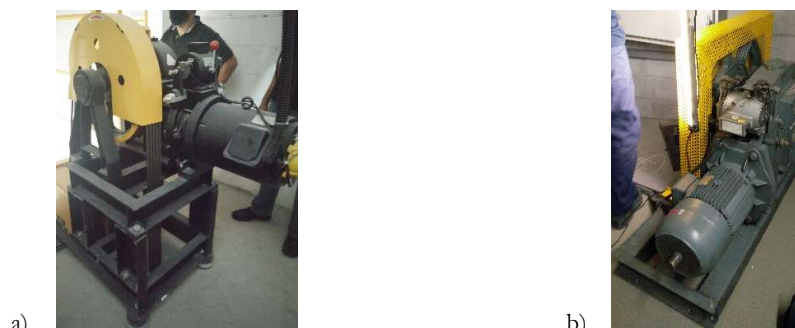
Figure 5 a-b) Both new installed drives with infinite transmission to the pulley system

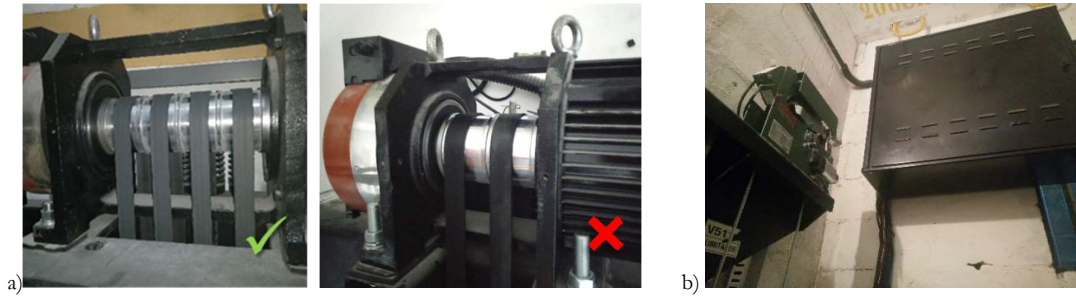
Figure 6 a) Compact drive with belts (instead of steel cables) and minimize drive space for a 5 floor-building (✓observation: belts should be centered to each axis section during operation by standard) b) speed governor (i.e. major security actuator against fall, present in all elevators) and Villarta's compact control box (photo; 01.2021)

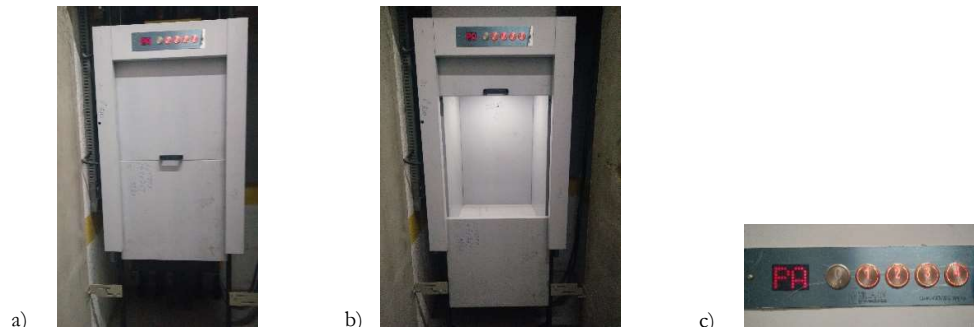
Figure 7 a-b) Cargo elevator with max load $m_{\max}=100$ kg c) button panel and display and 'guillotine' door mechanism (photo, 19.01.2021)

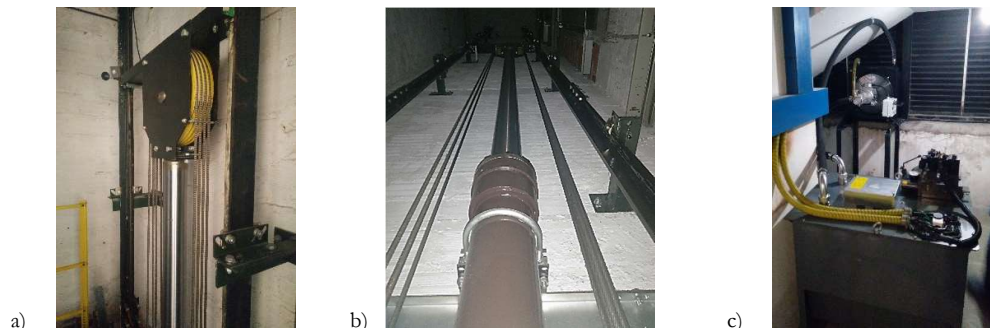
Figure 8 a) Piston top with wheel and steel cables b) driven piston c) Oil reservoir and cooling fan (photo, 12.2020)

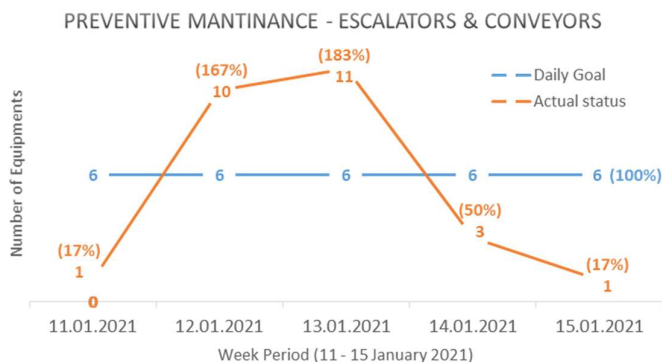
Figure 10 Goal of preventive interventions per week vs. actual interventions of the team in a week / *Meta de intervenções preventivas por semana versus intervenções reais da equipe em uma semana*

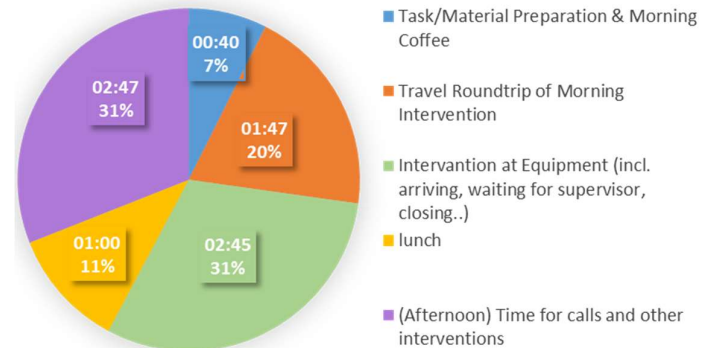
Figure 11 Task time of morning preventive maintenance intervention (Mean Value of Week) / *Tempo da tarefa da intervenção de manutenção preventiva matinal (Valor médio da semana)*

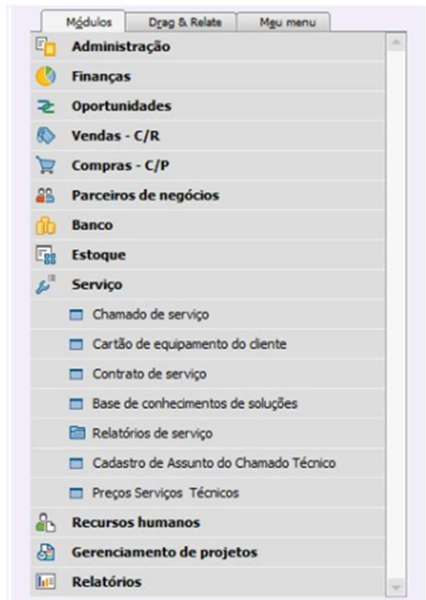
Figure 14 SAP interface for technical assistance service

Identified Problem: Response to sheet-reports for the RIA. The RIA is sent to the prefecture together with the ART (*Anotação de Responsabilidade Técnica*) document, which is regulated by the CONFEA (*Conselho Federal de Engenharia e Agronomia*). This document generates a cost and is covered, depending on agreement, by Villarta or the Lift Owner.

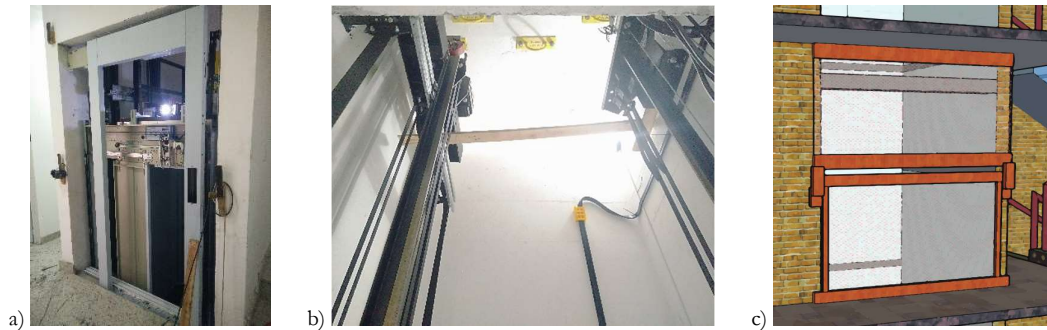
Figure 15 a) Floor-Door Installation b) Guiding and pulley structure during installation, yellow hooks installed by civil workers as prerequisite for installation c) Door protection example [6]

For organizational and bureaucratic reasons with some construction companies, the installation week was productive to visit only one construction site in an advanced stage. Other visits were rather completed and ready to handover. On this construction site, an electric elevator was installed without machine room and with traction belts. The elevation was a three-way lift for office use. The accompanying day consisted of the installation of the operator's doors and two mechanisms with their respective support panels. According to the manufacturer of the doors (Fermator), the door type 40/10 estimates an installation time of 25 minutes per door for 1 technician [5]. On site, it took 6 hours to install 3 doors (1 operator, 2 mechanisms) with 2 technicians. The reason was numerous adjustments that the technicians had to make and unmake repeatedly. One assumption is that the alignment of the components could have been more precise. Figure 15 shows details of this work.

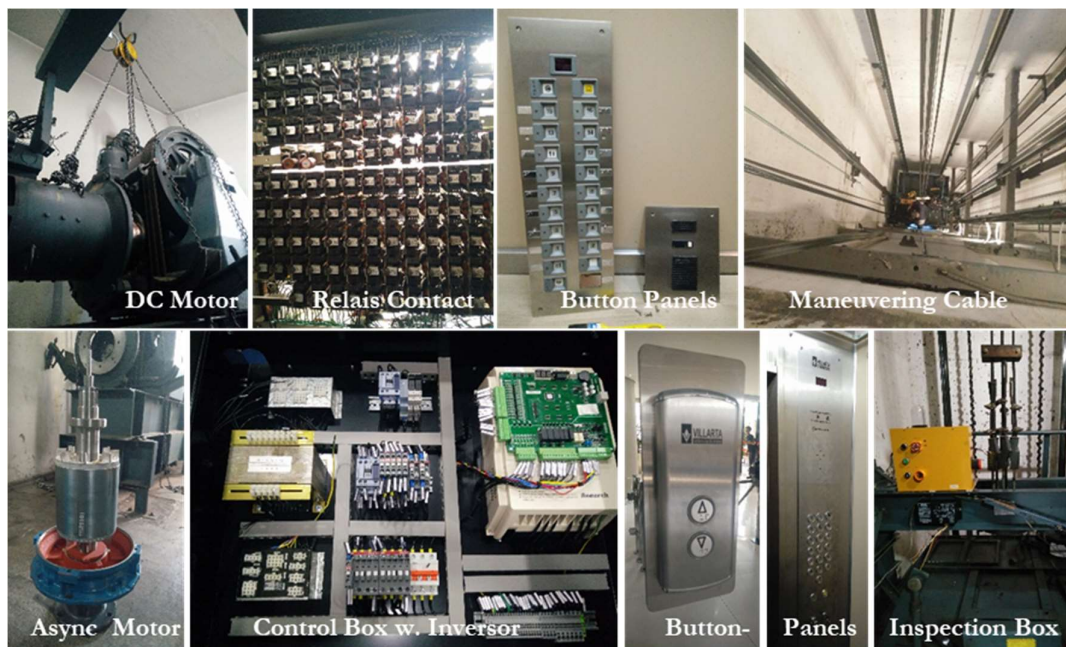
Figure 16 Before and after modernization of some components during rotation

- ❖ De-installation of Direct Current DC Generator
- ❖ De-installation of DC motor
- ❖ De-installation of old IPDs and button panels
- ❖ Installation of an asynchronous motor type WEG AC (Alternate Current)

- ❖ De-installation of stop selector (old contactor belt that operated the relays for each stop)

The control cabinet in the machine room substituted the old outdated relais contact principle. Instead, it implements a much simpler configuration as shown in Figure 16. Important devices that are located in the command box are for example the following [1]:

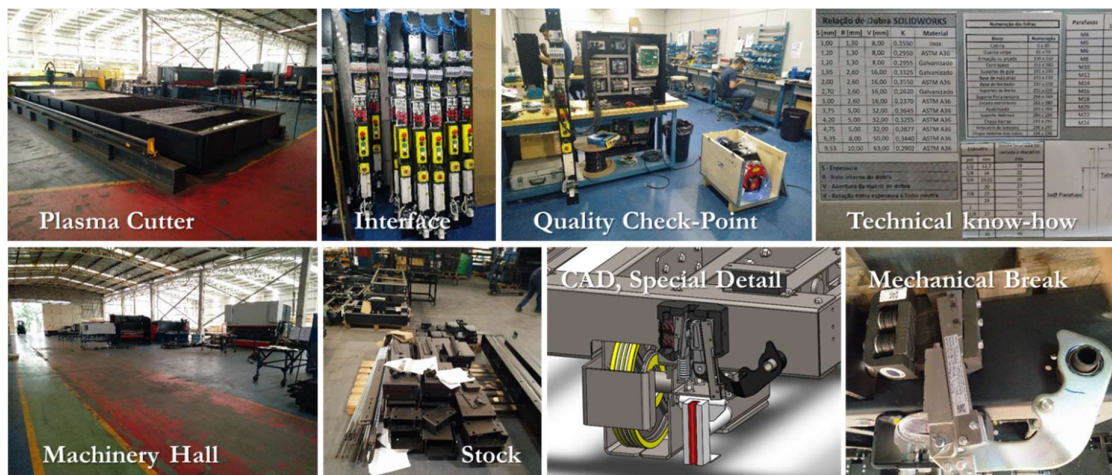
Figure 17 A week at Villarta Production Plant, Taubaté, Brazil

- #VIVAVIDA not attended: (sparks of operational laser cutter fly on the transport pathway as a potential harm to a passant at the end!!!) → Apply a protection fence, for example like one similar to the welding section, see Figure 17 'Plasma Cutter'

- Same machine invades the transport pathway (i.e. red zone), see Figure 17 'Laser Cutter'
- Drying parts at Painting station also invade the transport zone. Developing Vertical Rack Structures could reduce the items per area (m²)

- Mark and define functional spaces for specific items...where they systematically belong (sorting)...Example Figure 17 'Stock', a mix of non-systematically organized items can be seen

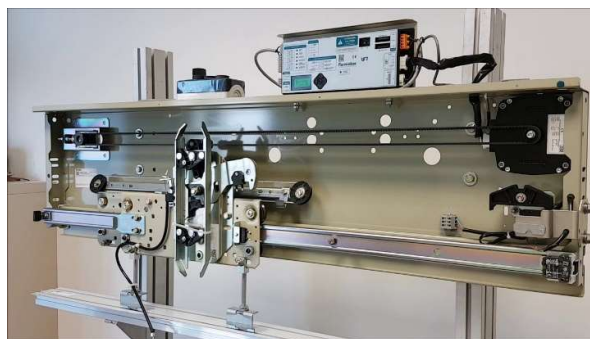
Figure 18 A Fermator Product: 40/10 PM Operator with Telescope Aperture, VVVF7 Module, Permanent Magnets (PM) Motor, Skates, Car Door Lock (CDL), Clips instead of Slides and Pit Egress Feature (Door Leafs excluded). Follows EN 81-20/50 [8]
